**“COST EFFECTIVE ALTERNATIVE METHODS FOR STEEL BRIDGE PAINT
SYSTEM MAINTENANCE”**
CONTRACT NO. DTFH61-97-C-00026

**Report III:
ABRASIVE INJECTED WATER BLASTING FOR THE REMOVAL OF
LEAD-BASED PAINT**

WRITTEN FOR THE FEDERAL HIGHWAY ADMINISTRATION
BY: CORRPRO COMPANIES INC.
Report: May 19, 1999

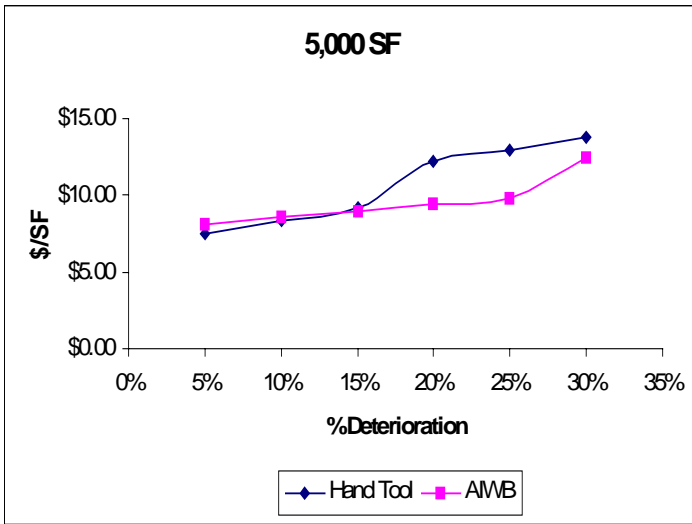
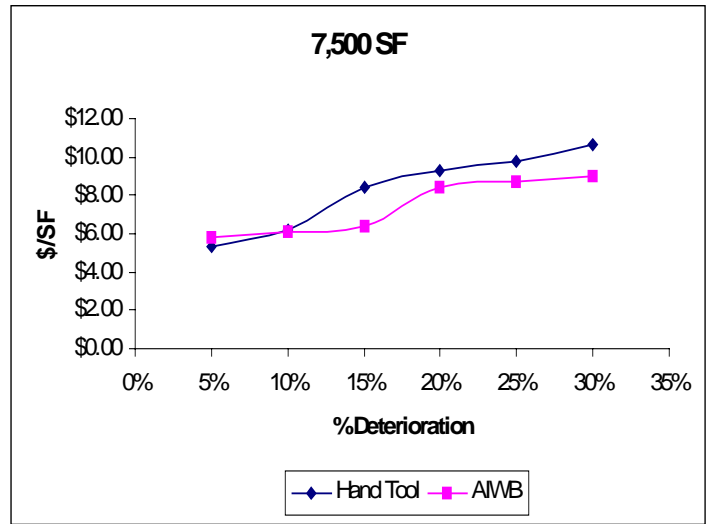
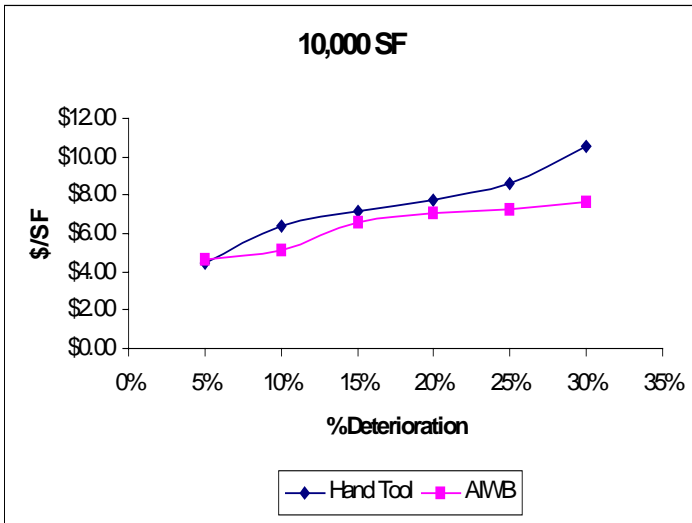
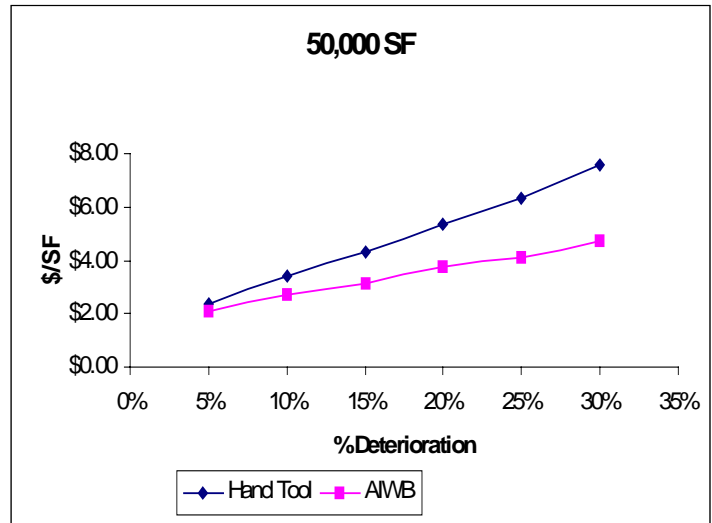
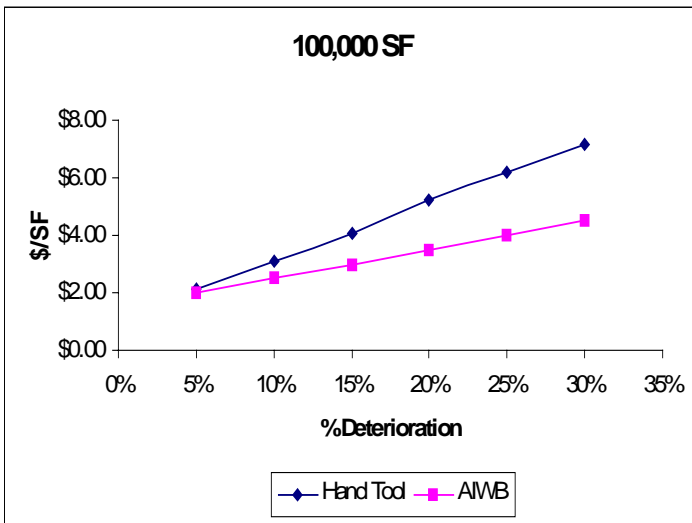
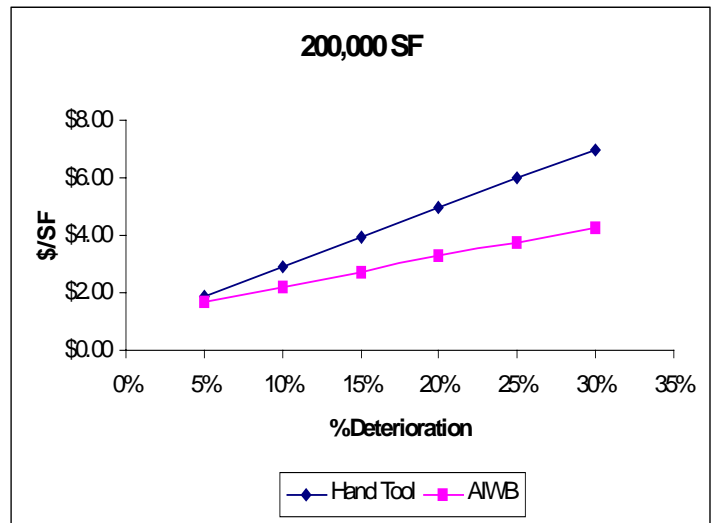
Figure 1. Graphical Representation of % Deterioration vs. Cost per square foot (\$/SF)

As the data shows, AIWB is close in price to hand/power tool cleaning when deterioration is minimal, but becomes the more economically viable option when deterioration increases. This data is also shown graphically in Figure 1 of Appendix A. Another useful piece of data in determining the economic viability of AIWB is the critical deterioration point. The critical deterioration point is defined as the percent deterioration for which the cost of abrasive injected water blasting approximately equals the cost for hand/tool power tool cleaning. This point occurs at different levels of deterioration depending on the size of the structure. Table 1.6 summarizes these critical points.

This cost model calculated cost for maintenance painting of structures with varying extents of coating deterioration for a comparison between abrasive injected water blasting and hand/power tool cleaning surface preparation methods. The results are summarized in Table 1.5.

It can be seen that as the structure size increases, the critical deterioration point decreases. One can then infer that AIWB becomes more viable as the structure size increases.

4. Costs for hand/power tool cleaning were similar to that of AIWB for minimal deterioration, but became considerably more at higher percent deterioration. This was especially true for the larger structures where the cost increased by as much as 57% for hand/power tool cleaning.
