“COST EFFECTIVE ALTERNATIVE METHODS FOR STEEL BRIDGE
PAINT SYSTEM MAINTENANCE”

CONTRACT No. DTFH61-97-C-00026

REPORT X:
MAINTENANCE PAINTING MATERIALS:
LABORATORY EVALUATION OF FOIL TAPE COATING VERSUS
MOISTURE CURED URETHANE COATINGS

WRITTEN FOR THE FEDERAL HIGHWAY ADMINISTRATION
BY: CORRPRO COMPANIES INC.
REPORT: SEPTEMBER 25, 2001

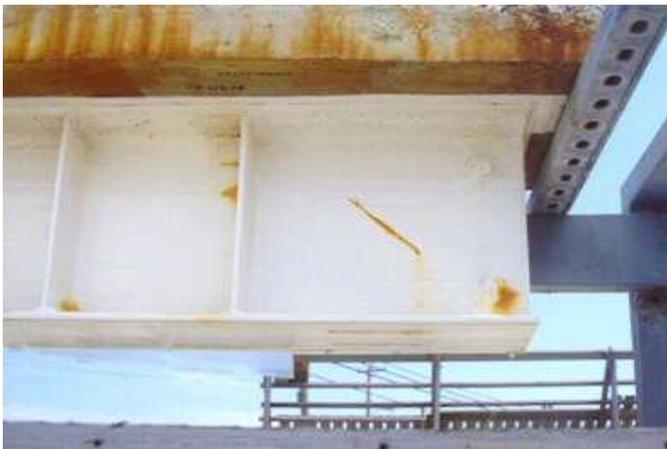
simulated a bridge deck exposure and configuration. Two (2) 36” long W 10X22 beams were pre-exposed at our beachfront weathering facility prior to use. One half of each beam was prepared to SSPC SP-2 and the other half prepared to SSPC SP-6 using Aluminum Oxide Blast media. Chlorides were measured on these surfaces. An example of the concrete embedded beams is

Figure 1. Example bridge simulation beam at the marine weathering facility (looking up at the beam).

shown in Figure 1. This semi-sheltered exposure represents an actual bridge beam with a concrete deck overhead.

Structural “I-beams” were embedded in concrete and inverted for exposure. These

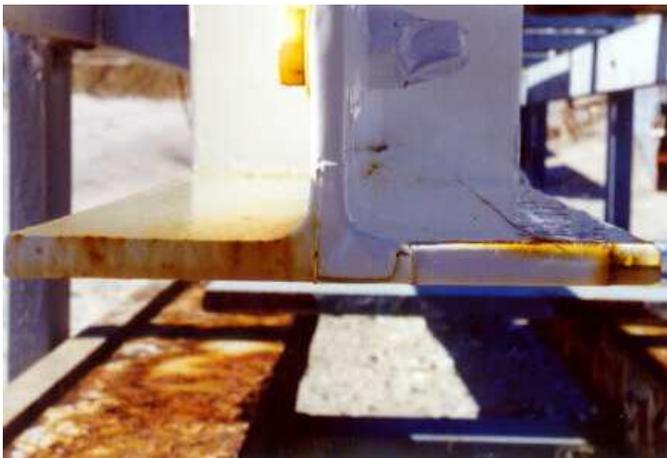
Figure 2. End of test beam showing MCU system on left and Corrofoil on right.

Figure 2 shows the end portion of the test beam prepared to SSPC SP-6. The tape coating system with a primer and topcoat is on the right side of the beam and the 3-coat MCU system is on the left side of the beam. There is

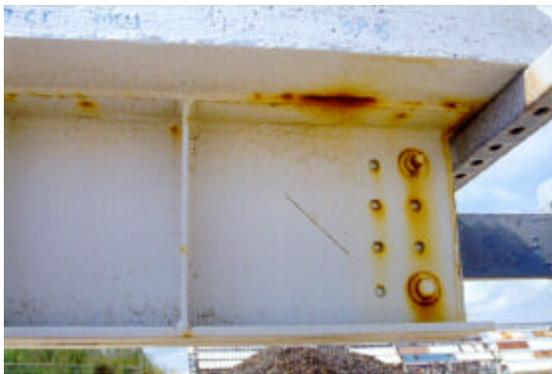
Figure 3. Test beam section coated with a 3-coat MCU system.

Figures 3 and 4 show photographs of an MCU coated beam section and a beam section with the tape coating system. The bolt holes and edges of the MCU beam are showing some rusting, but the scribe cutback for this coating was less than that of the tape coating system (also see Graphs 4 and 5). The tape coating did, however provide a more aesthetically acceptable surface by hindering the appearance of corrosion at many edges and irregular surfaces. Corrosion products were limited to staining that originated from the seams in the tape coating.

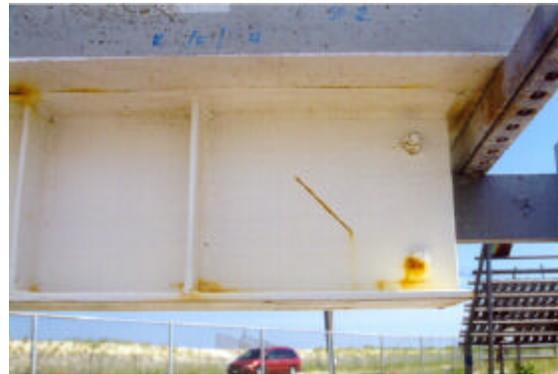
Figure 4. Test beam section coated with epoxy primer, Corrofoil, and a polyurethane topcoat.

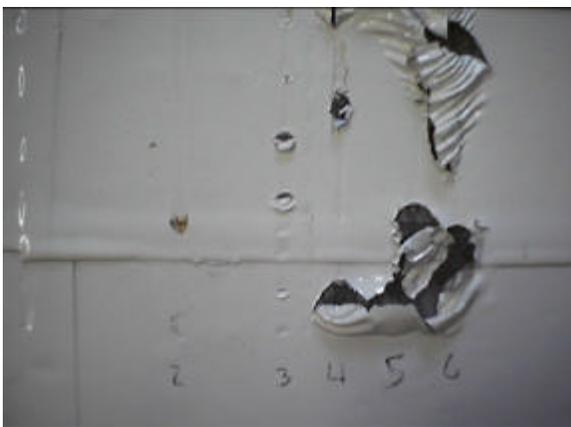
Figure 5. Example test results – Corrofoil after scratch adhesion testing.

The failure mode of the tape system in the scratch adhesion test was not amenable to reliable data interpretation. The foil tended to tear and cause the stylus to skip along the panel during this test. Figure 5 shows an example panel with the tape coating system.
